NAVAL AVIATION SAFETY CENTER

A & R DEPARTMENT NARRATIVE CODE SHEET SMD 5293 (New 11/64)

1. AIRCRAFT ACCIDENT BOARD APPOINTED BY NATF(SI)	2. SERIAL NO. 1-65A	3. DTG (LOCAL) OF MISHAP 311407Z AUG.	4. MODEL AIRCRAFT NA43	5. BUREAU NUMBER 142685
6. TO: Commander, Naval Aviation Safety Center	9. LOCATION OF MISHAP NAS Lakehurst, N. J.	10. DAMAGE ALFA		
7. VIA (1) CO, NATF(SI) NAS Lkhst NJ*	11. TIME OF DAY 1407Z	12. TIME IN FLIGHT 0400	13. FLIGHT CODE 1K1	
(2) CO, NAS Lakehurst, N. J.	14. CLEARED FROM: NAS Lakehurst, TO: NAS Patuxent River			
(3) CO, NATC, NAS Patuxent River, Maryland	15. TYPE CLEARANCE VFR	16. AIRSPEED 150 P.	17. A/C WEIGHT 22,100	
(4) BUWEPs	19. ELEVATION AT TIME OF MISHAP S.L. 102' TERRAIN 0'			
18. BRIEF DESCRIPTION OF MISHAP Aircraft over-ran runway on take-off				
20. LIST MODEL, BUNO, REPORTING CUSTODIAN AND DAMAGE CLASSIFICATION OF ANY OTHER A/C INVOLVED (Complete OPNAV Form 3750-1 for each A/C)

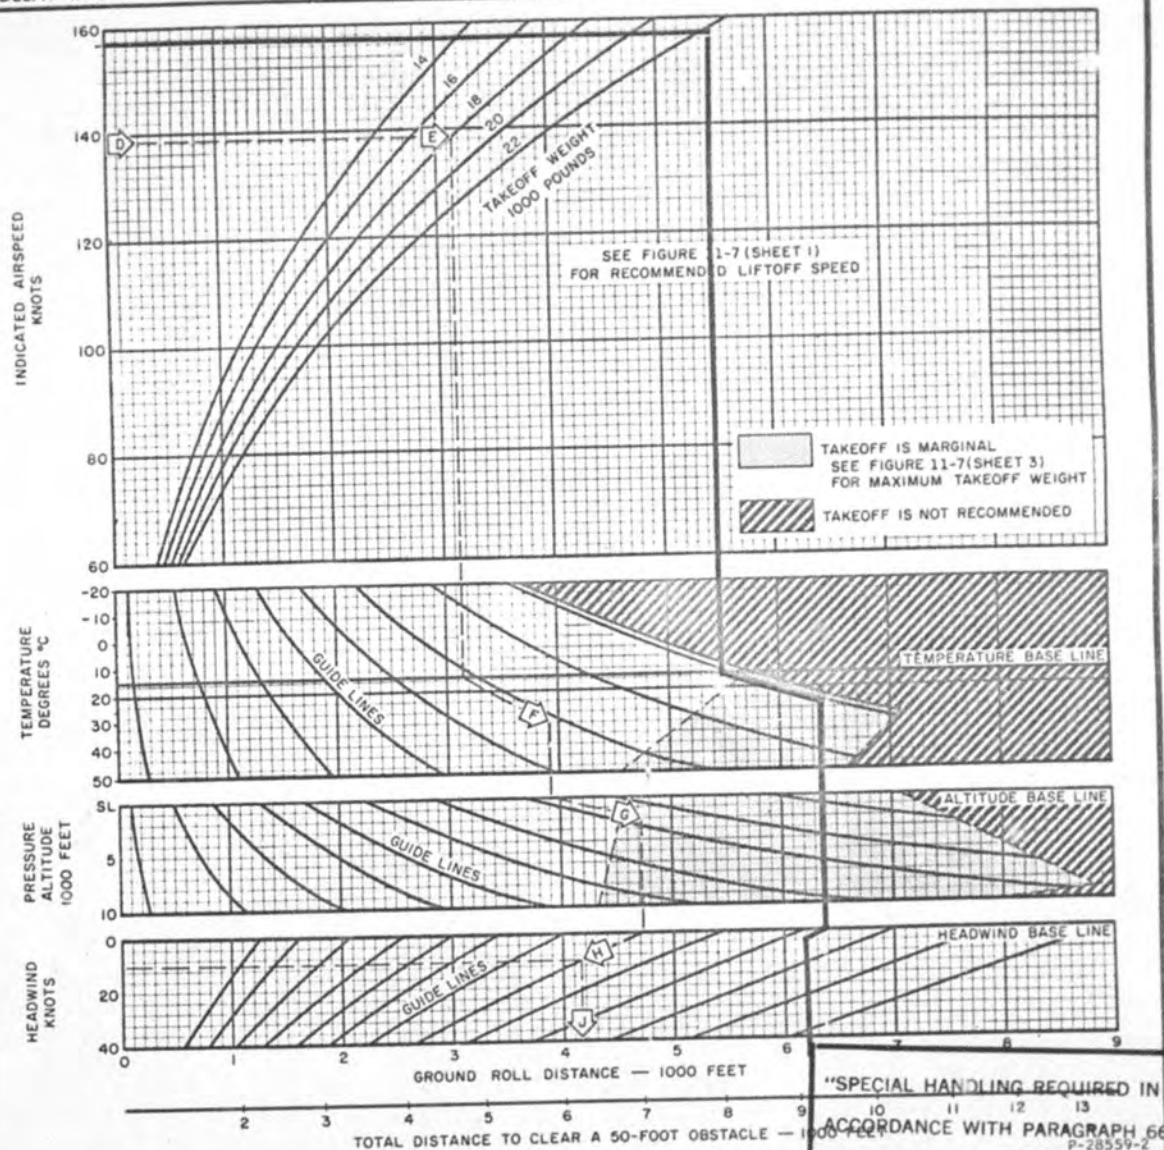
ENGINE: J65-W-16A

MODEL: A-4A/B

REMARKS:

1. Takeoff distances are based on engine delivering military thrust.
2. For takeoff over a 50-foot obstacle, read total distance on scale below ground roll distance **J**.
